AFRL-AFOSR-UK-TR-2015-0002

Fatigue micromechanism characterization in carbon fibre reinforced polymers using synchrotron radiation computed tomography

Report Date: December 2014

Final Report from 1 October 2011 to 30 September 2014

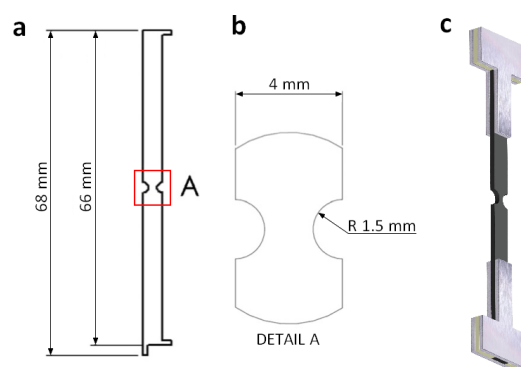
Figure 1- Coupons used: (a) geometry and dimensions of the specimen, (b) detail of the notch, and (c) specimen with tabs bonded.

Materials were laid up and auto-clave cured as flat plates using a standard aerospace cure cycle [19-21]. Rectangular coupons containing two semi-circular notches of radius 1.5 mm were introduced by water jet cutting, leaving a nominal central cross-section between the notches of 1 mm.

The geometry and the dimensions of the specimens used are shown in Figure 1. The coupon length was selected with the requirement to fit the specimen into the compact/portable fatigue-loading device to perform *ex situ* and *in situ* experiments, which resulted in lengths of 68 mm and 34 mm respectively. In addition, for the specimens used for *ex situ* scans, aluminium tabs were glued with the aim of loading them in the tensile rig. The average ultimate tensile failure strength (UTS) for each material system has been evaluated in previous studies [16], and is calculated based on the failure load and the net cross-sectional area between the notches. Values reported are: 918 MPa for the particle-toughened system, 1419 MPa for the untoughened, and 1271 MPa for the intrinsically toughened system [16].

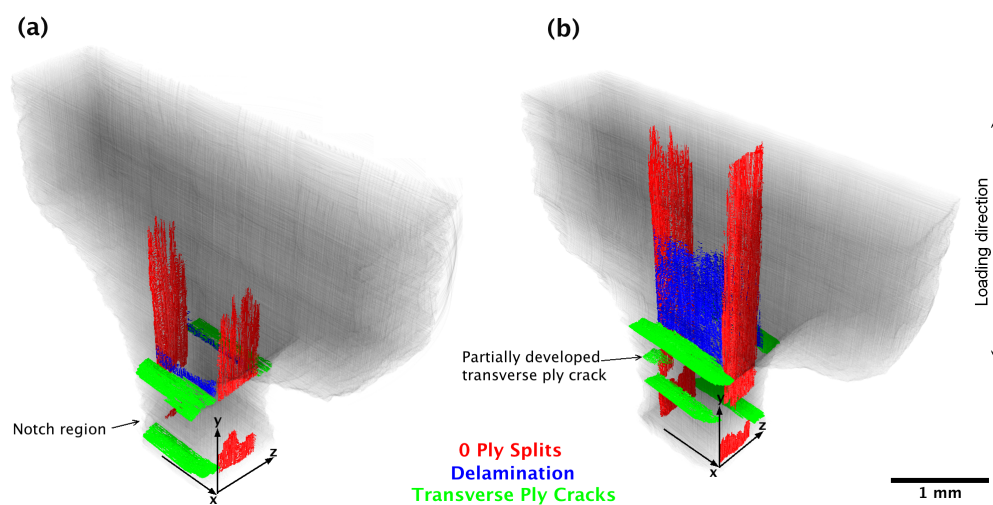
Figure 2 – Three-dimensional fatigue damage for: (a) 30% UTS and (b) 50% UTS, at 10^4 load cycles.

Damage quantification has been conducted focusing on the evaluation of the crack length and crack opening displacement of 0° ply splits, as shown in Figure 8. Three-dimensional damage rendering, shown in Figure 2, demonstrates that 0° ply splits are not planar; however, the COD map represents a 2D projection of the split onto the plane of the 0° plies, obtained by summing the voxels in the through-thickness direction. Figure 8(a) and Figure 8(b) show the crack opening contour map of 0° ply splits grown in fatigue loading at 30% and 50% UTS respectively for 10^4 cycles; where red corresponds to large values of COD, and blue regions are uncracked. The COD maps again show that the crack front growth does not advance evenly.

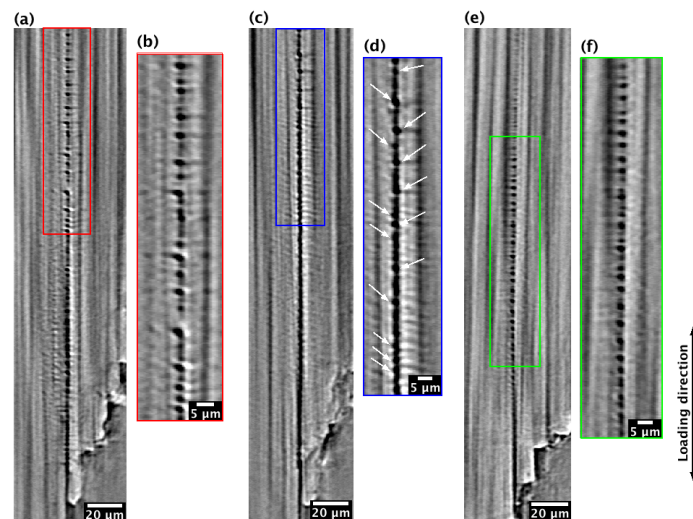
Figure 3 - Cross-sections parallel to the loading direction of 0° ply split: (a)-(b) discontinuous fatigue damage initiation for a peak load of 30% UTS and 200 cycles, (c)-(d) continuous fatigue damage for a peak load of 30% UTS and 200 cycles, (e)-(f) quasi-static case for a load of 35% UTS.

The results obtained from the fatigue tests showed that particles do not exhibit an active role in terms of 0° ply split initiation, and do not represent the location where damage occurs in the first instance. Cracks nucleate in the resin between fibres in the fibre-packed regions within the 0° plies (Figure 3(a)), and at this early stage do not

propagate into the resin rich regions. Damage is discontinuous: many parallel microcracks initiate, separated from each other by the presence of small bridging ligaments (on the order of a few micrometers), as is clearly visible in Figure 3(b). The small bridging ligaments detected along the fibre/matrix interface fail progressively due to cyclic loading, as shown in Figure 3(c) and 3(d), where the nucleation locations are indicated with white arrows. The bridging between them, as shown in Figure 3(b) is failed and the crack appears continuous. A direct comparison with the quasi-static case (Figure 3(e) and 3(f)), using a similar peak load, exhibits similar behaviour to the fatigue case (Figure 3(a) and 3(b)), *i.e.* locally discontinuous crack formation.

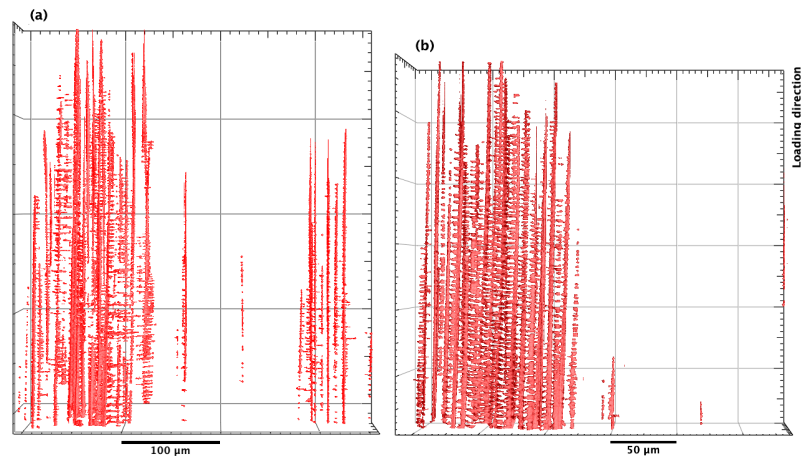
Figure 4 – Three-dimensional rendering of damage initiation in the fibre-packed regions: 0° ply split in (a) fatigue case with peak load of 30% UTS up to 200 cycles, (b) quasi-static case for a load of 35% UTS.

Three-dimensional rendering of the 0° ply splits for the fatigue and quasi-static case are reported in Figure 4. A somewhat longer crack length, larger number of crack initiation sites across the ply thickness, and longer single “spikes” characterize the fatigue case, as shown in Figure 4(a). In contrast, the quasi-static case shows damage mainly localized over only half of the ply thickness, with smaller and more frequent peaks, as shown in Figure 4(b). A noticeable difference between the two loading conditions is a reduction in the number density of bridging ligaments in the fatigue case, Figure 4(a).

From these observations it appears that the initial stage of fatigue damage development consists of the nucleation of very localized cracks, which tend to grow parallel to the loading direction. Their coalescence across the ply thickness (perpendicular to the loading direction) is initially limited. The quasi-static case displays more apparent connections between initiation sites across the ply thickness (split width), and more bridging ligaments along the loading direction, as shown in Figure 4(b).

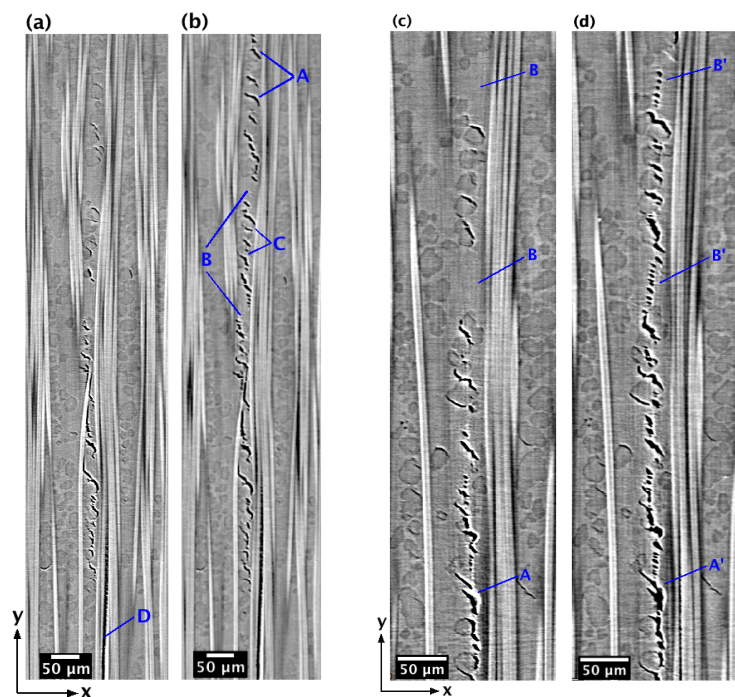
Figure 5 - 0° ply split growth propagation in the particle toughened system within the resin rich region for a peak load of 50% UTS: two comparisons at 700 cycles and 800 cycles (corresponding to (a)-(b) and (c)-(d)).

shown in Figure 5b. Damage progression is seen to be highly discontinuous, with crack extension being dominated by the growth and coalescence of many small cracks, rather than the progression of a dominant crack tip. The primary process of damage propagation at the nominal crack tip, defined as the furthest extent of the damage zone, is represented by particle debonding (Figure 5b, (A)), which results in the creation of bridging ligaments along the crack wake. The process is distributed over a length of approximately 1 mm around the nominal crack tip, with partially debonded particles remaining intact relatively far behind the nominal crack tip (over several hundred micrometers) and acting as bridging ligaments between the crack flanks.

The periodicity and scale of microcracking is clearly defined by the particle size and separation distances, as shown in Figure 5b. Crack bridging ligaments consist of resin between particles debonds (e.g. Figure 5b, (B)) and/or particles themselves (e.g. Figure 5b, (C)). The presence of particles clearly promotes crack deflection, increasing the crack path tortuosity and the surface roughness. Figure 5a, (D) shows the difference between the split growth propagation along the fibre/matrix interface, which appears smooth/straight, versus the damage developed in the resin rich region, characterized by significant crack deflection. Considering another region of interest in

the coupon (Figure 5(c) and 5(d)), several bridging ligaments present at 700 cycles (Figure 5c (A) and (B)) are removed, wholly or partially, at 800 cycles (Figure 5d (A') and (B')). Two different behaviours have been detected, depending on the resin ligament size: (i) small bridges (on the order of $\sim 10\text{-}20\text{ }\mu\text{m}$); these fail by connecting adjacent microcracks along the direction of damage propagation, as shown in Figure 5d (A'); and (ii) large ligaments (on the order of $\sim 50\text{-}100\text{ }\mu\text{m}$ cross-section), fail by the formation of local echelon cracks within the bulk resin itself (i.e. not from toughening particles) at 45° to the loading direction, as shown in Figure 5d (B). Toughening particles act also as bridging ligaments when they are partially debonded along the crack wake, as shown in Figure 5d (C).

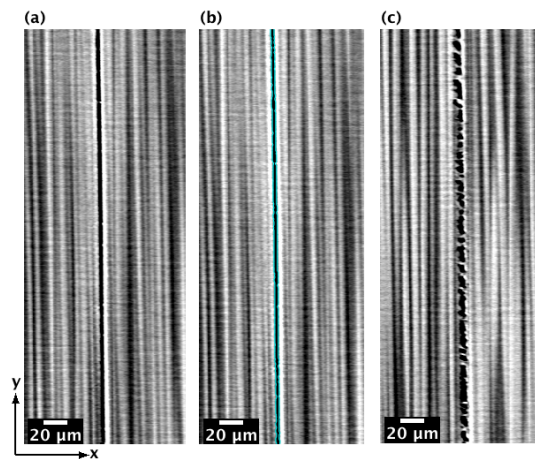
Figure 6 - 0° ply split propagation in the untoughened system: within the fibre packed region (a) with representation of the segmented damage (b), and in correspondence with fibres surrounded by resin (c). Peak load of 50% UTS and 700 cycles.

When the fibres are surrounded by resin, the crack propagation was seen to be discontinuous, assuming the form of small microcracks at the fibre/matrix interface, retaining very small resin ligaments (on the order of a few micrometers), e.g. Figure 6c.

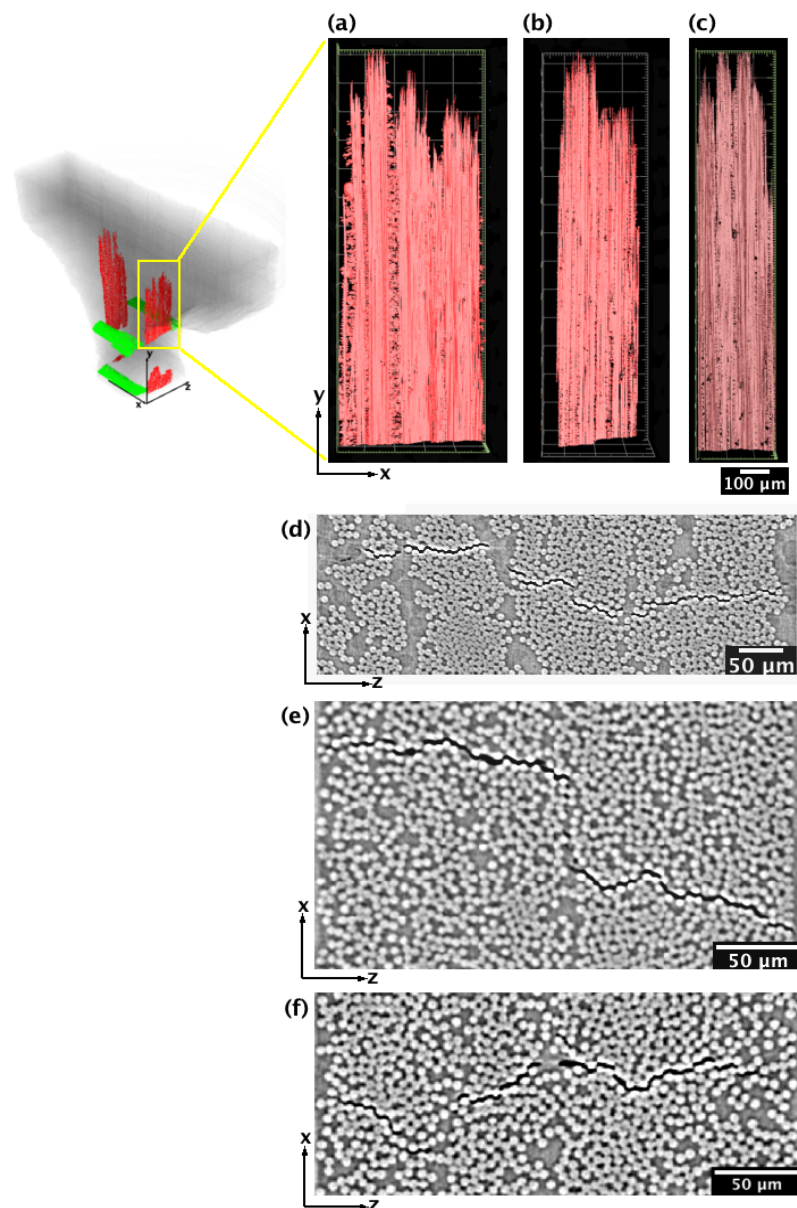
Figure 7 - Three-dimensional rendering of the 0° ply split, with a typical cross section perpendicular to the loading direction: (a), (d) particle-toughened system; (b), (e) untoughened system; and (c), (f) intrinsically toughened system. Peak load of 50% UTS and 800 cycles.

Two-dimensional slices were exploited to segment fatigue damage and provide a 3D representation of the crack front profile, as shown in Figure 7. The investigation was focused on 0° ply splits with different crack profiles being detected, depending on the matrix system, and in particular on the interaction between damage and the local microstructure. The three-dimensional rendering of the damage within the particle-toughened system (Figure 7a) confirms that particles play a fundamental role in crack development. The local crack path is three-dimensional with a roughness and tortuosity defined by the particle size, with the crack and associated damage occupying a fraction of the intra-ply resin rich regions. By contrast, the untoughened material exhibits much more planar/uniform crack surfaces, with 3-D features largely determined by the scale of the fibre diameter and the inter-fibre spacing.

Figures 7a-c show plan views of splits from each material. Toughening mechanisms in the particle system are seen to act locally, within bands in the material, resulting in local fracture energy dissipation, consistent with the uneven crack advance, as shown in Figure 7a. The presence of retarded zones (pinning of the crack front) is related to the location of resin-rich regions containing the majority of toughening particles, which inhibit crack propagation, as shown in the cross-section perpendicular to the loading direction, Figure 7d. The result is a crack front that exhibits a “jagged” shape (Figure 7a), characterized by extended crack growth in the high fibre volume fraction regions, associated with extensive debonding of fibre/matrix interfaces. Figure 7b displays the 0° ply split segmentation for the untoughened system. Split propagation at the matrix/fibre interface is more uniform across the ply split width due to the absence of resin and particle-rich bands.

The intrinsically toughened system demonstrated an intermediate behaviour, between that of the particle-toughened and the untoughened systems, as shown in Figure 7c. In particular, even though no toughening particles are present within the matrix, the resin rich regions act as crack retardation sites, creating non-uniform crack growth. The cross-section perpendicular to the loading direction presented in Figure 7f confirms

that the split is constrained by a resin-pocket, whereas in fibre rich volumes crack growth is extended. The density of bridging ligaments along the crack wake is much less than for the particle-toughened system but is slightly higher than for the untoughened system.

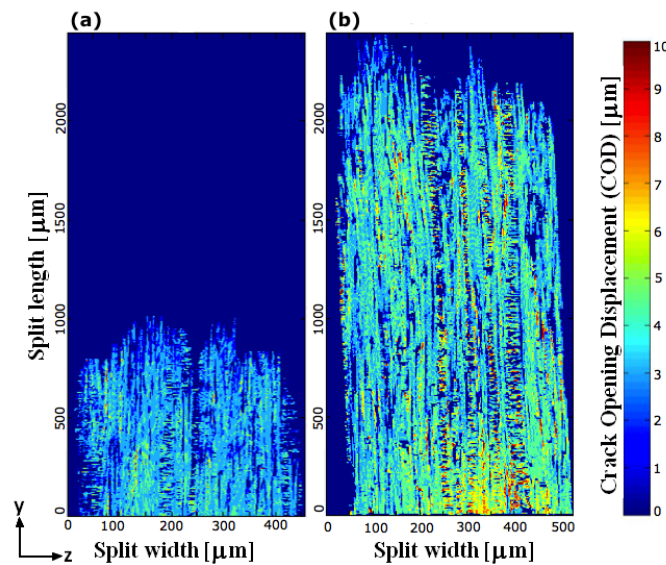
Figure 8 - Fatigue crack opening displacement mapping for 0° ply splits at: (a) 30% UTS and (b) 50% UTS (10^4 cycles).

The COD map for an applied load of 30% UTS, Figure 8(a), exhibits two main regions across the split width (ply thickness) separated by a large resin rich region located roughly in the middle ($250 \mu\text{m}$), at the interface between the two central 0° plies. Both regions, from $50\text{--}220 \mu\text{m}$ and the other from $270\text{--}420 \mu\text{m}$, are characterized by a jagged crack front; with a similar overall extent on each side and retarded crack growth close to the interfaces with the 90° plies, i.e. from $0 \mu\text{m}$ to $50 \mu\text{m}$ and from $420 \mu\text{m}$ to $450 \mu\text{m}$, where the crack interacts with particles at the interfaces. Another prominent resin rich region is located between $180\text{--}200 \mu\text{m}$. The COD values appear similar across the majority of the split, with average values on the order of $2.5\text{--}3.5 \mu\text{m}$ at the root and $1.5\text{--}2.5 \mu\text{m}$ in the region $200 \mu\text{m}$ back from the crack tip. The COD map obtained for an applied load of 50% σ_f is shown in Figure 8(b). Similar behaviour at the lower load is observed: two main zones are visible across the split width (ply thickness), from $50 \mu\text{m}$ to $250 \mu\text{m}$ and from $270 \mu\text{m}$ to 500

these two different split lengths. For instance, at a position of 500 μm back from the crack tip for both loading conditions, the COD is lower for the lower load case. This is in part simply attributable to the load difference, but it is also clear that there has been additional degradation of crack wake bridging ligaments at the higher loading. In particular at the central ply interfaces, close to the crack tip, there is a smaller intact bridging region at the higher load case (8(b)) compared to that present in the lower load case (8(a)).

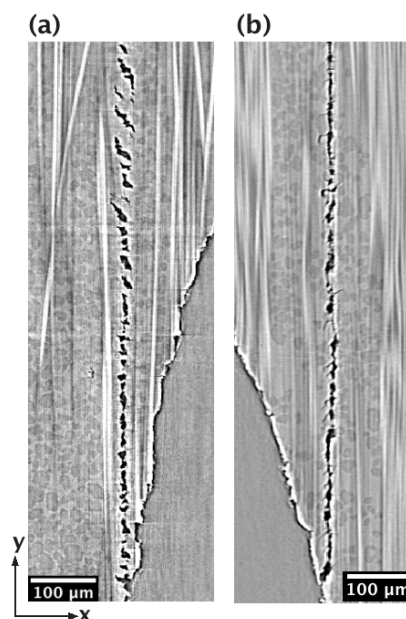
Figure 9 - Comparison of the micromechanical behaviour along the 0° ply split in (a) quasi-static case loaded to 60% UTS, and (b) fatigue loaded to 50% UTS with number of cycles of 10^4 .

Qualitative analyses via 3D rendering of damage demonstrate broadly similar behaviour between fatigue and quasi-static loading [15] in terms of crack location and shape. However, fatigue loading results in more extensive damage than for quasi-static loading at the same peak load. In addition, delamination is *not* detected under quasi-static loading for these load levels, whereas delamination is clearly observed in the fatigue case. In both quasi-static and fatigue a similar correlation between intralaminar damage and microstructure was observed, suggesting broadly similar micromechanical behaviour of 0° ply split propagation in resin rich regions and high-fibre volume fraction regions. Figure 9 displays a cross section of a 0° ply split in a resin rich-region for quasi-static loading (Figure 9(a)), and for fatigue (Figure 9(b)); both cases loaded at 50% UTS.

The discrete microcracks in the resin rich regions are much more apparent in the quasi-static loading case, as shown in Figure 9(a). In cyclic loading the bridges between the individual microcracks appear to have largely failed, presumably due to local cyclic degradation, yielding more continuous cracks as shown in Figure 9(b).

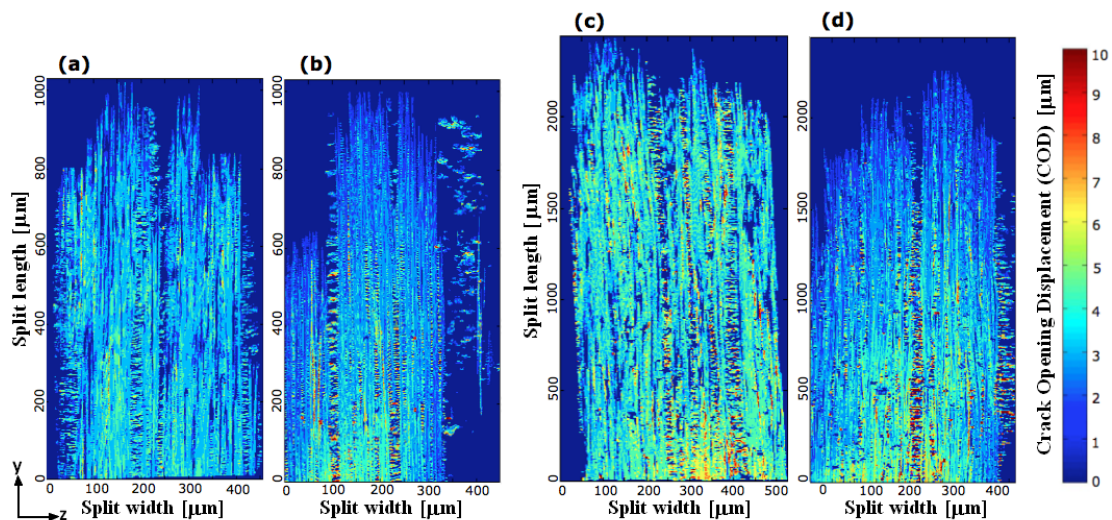
Figure 10 - Split crack opening displacement contours: (a) crack length of 1 mm: fatigue case with peak load of 30% UTS and 10^4 cycles, (b) quasi-static case for 70% UTS; crack length of 2.5 mm: (c) fatigue case with peak load of 50% UTS and 10^4 cycles, and (d) quasi-static case for the load of 60% UTS.

The fatigue-loaded specimens show more uniform crack advance across the ply thickness, along with more uniform crack opening displacement over the area of the crack (width and length). In terms of uniformity of crack length across the ply thickness (split width), large uncracked resin rich areas characteristically seen in static load cases (e.g. a band of $\sim 100\mu\text{m}$ width along the right hand ply interface of the 0°

ply split in Figure 10(b)) were largely absent in the fatigue loading cases. Comparing Figure 10(a) with 10(b) and Figure 10(c) with 10(d), it is apparent that in the quasi-static cases (10b, 10d) there is a significantly higher crack opening displacement towards the centre line of the 0° ply split and/or the centre line of the resin rich regions. Figures 10(a) and 10(c), associated with fatigue loading, show more uniform crack opening displacements across the ply thickness. The comparison between these two loading conditions highlights the presence of higher average values of COD in the fatigue cases (Figure 10a, 10c), even though the applied loads were higher for the quasi-static cases (Figure 10b, 10d). In the first instance, this is consistent with a reduced number and strength of load bearing ligaments in the wake of the fatigue cracks, and/or the corresponding incidence of delamination in fatigue. The presence of delamination in the fatigue case could affect the COD due to the fact that the 0° plies are less constrained. However, the delamination is not completely developed along the split length, as shown in Figure 2, extending only along 10% and 35% of the total 0° ply split lengths considered for the COD maps for the cases of loading at 30% and 50% σ_f respectively. Quasi-static cases showed no delamination for the smaller crack and minimal of delamination for the longer crack (amounting to ~5% of the 0° ply split length). As such, higher CODs for the fatigue cases compared to similar split lengths in quasi-statically loaded specimens are consistent with the local degradation of bridging ligaments under fatigue loading, as illustrated in Figure 10(a) and 10(c), resulting in reduced effectiveness of bridging and higher crack opening and shear displacements.
